ABOVE GROUND STORAGE TANK PROTECTION

McCook County Highway Department Salem, SD

Fortify 3 year old paint beginning to fail on an above ground asphalt storage tank

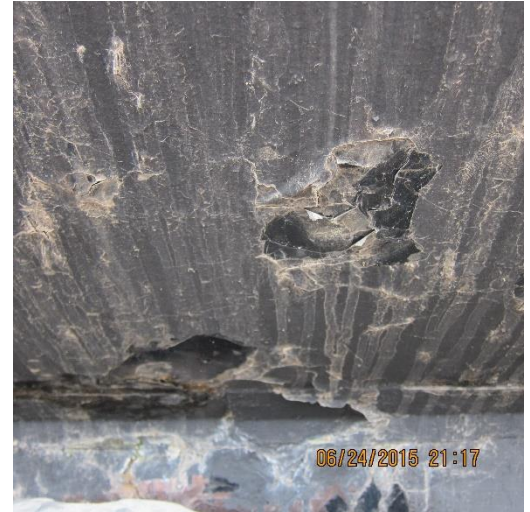
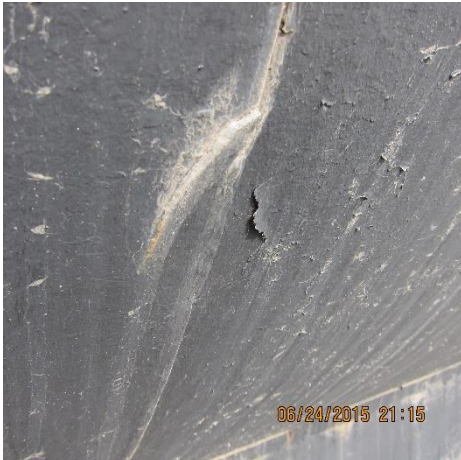
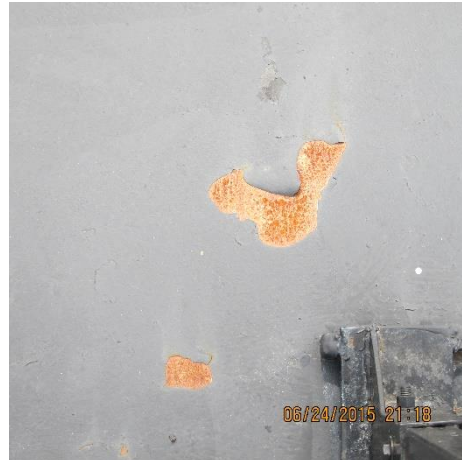
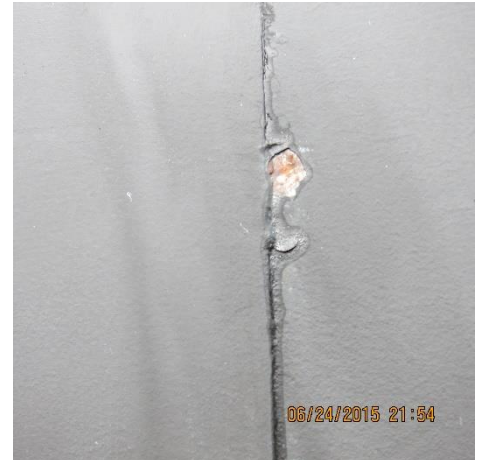
Over the years exposure to the UV and weather deteriorated the paint system resulting in oxidation to all of the paint on the storage tank.

There were areas the paint had peeled away from the substrate.

In some areas the paint had fallen off exposing the steel substrate forming rust which will result in asset damage in terms of structural material loss.

The county agreed to use **NCI** on one of the tanks as a field trial to fortify the existing paint system extending its service life so as not to have to re-paint the tank which would have cost significantly more money in material and labor.

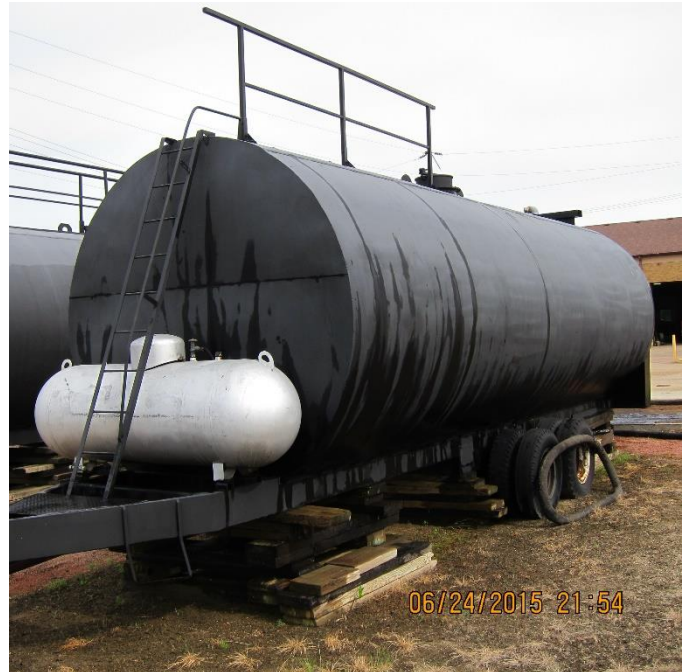
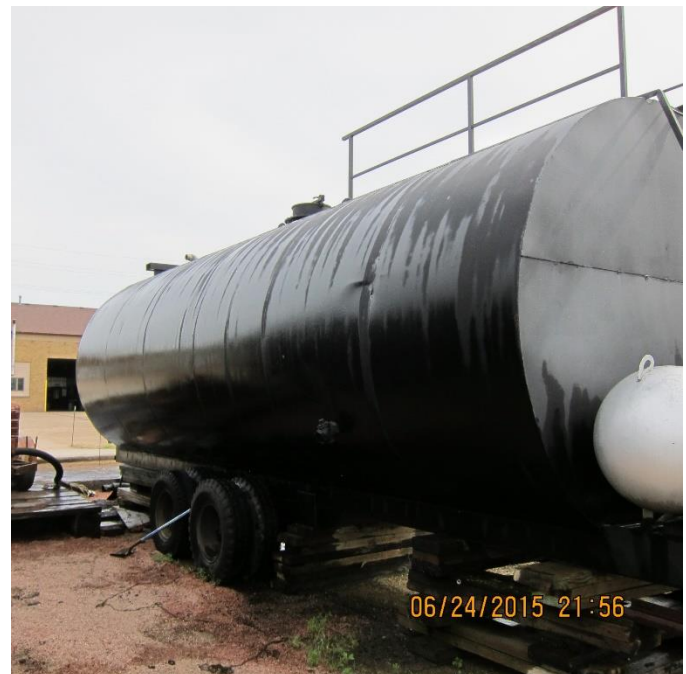
NCI was applied to the top of the tank with a paint pad. Coverage was good but progress was slow due to several penetrations, weld lines and handrail on the tank. Application by HVLP gun would have been a better choice and was used for the rest of the storage tank.

The oxidized paint required applying a second wet-on-wet coat of **NCI** because the porous paint surface absorbed the **NCI** at different rates which left some areas looking “patchy”. After the second coat the differences between areas evened out.

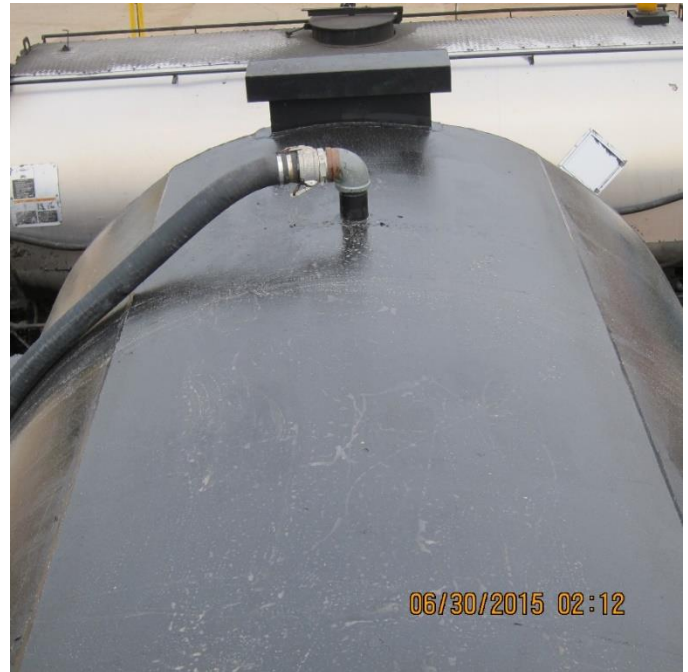
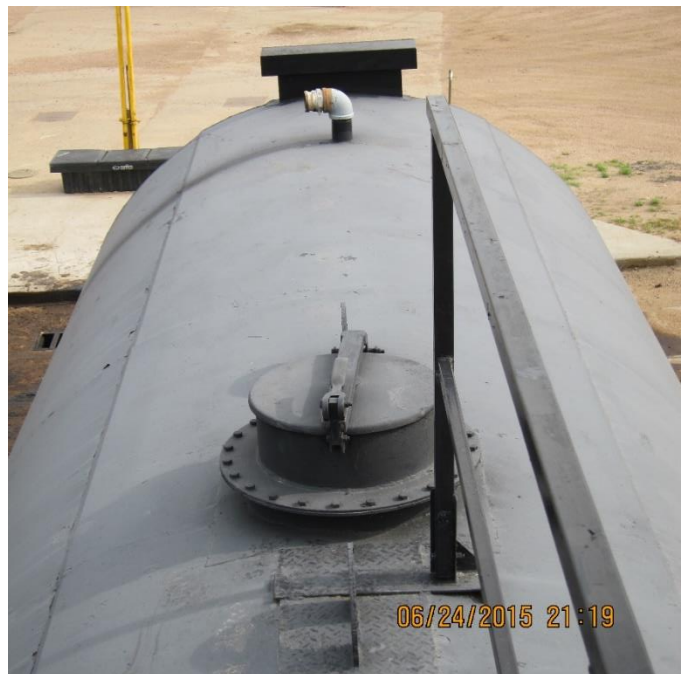
An HVLP gun was used to coat the rest of the storage tank. A ladder was used to reach the top of the storage tank with one person holding the ladder for the applicator.

- The applicator began the spray application process at the top of the tank overlapping the top area of the tank previously applied with the paint pad.
- The storage tank is made of “ring” sections” and the applicator started at the top of the ring section applying the **NCI** side-to-side working down the section.
- After the applicator covered an area he could comfortable and safely reach he returned to where he started and sprayed the area again using a crosshatch method going up and down across the section. This cross-hatch spray technique results in an even coverage of the substrate.
- After the section was complete the applicator stepped down from the ladder and repeated the procedure on the bottom portion of the ring section completing that ring.

We moved the ladder to each ring section repeating the application procedure. When each side/end was complete the applicator reviewed the storage tank so see where areas that needed to be touched up to even the finish.

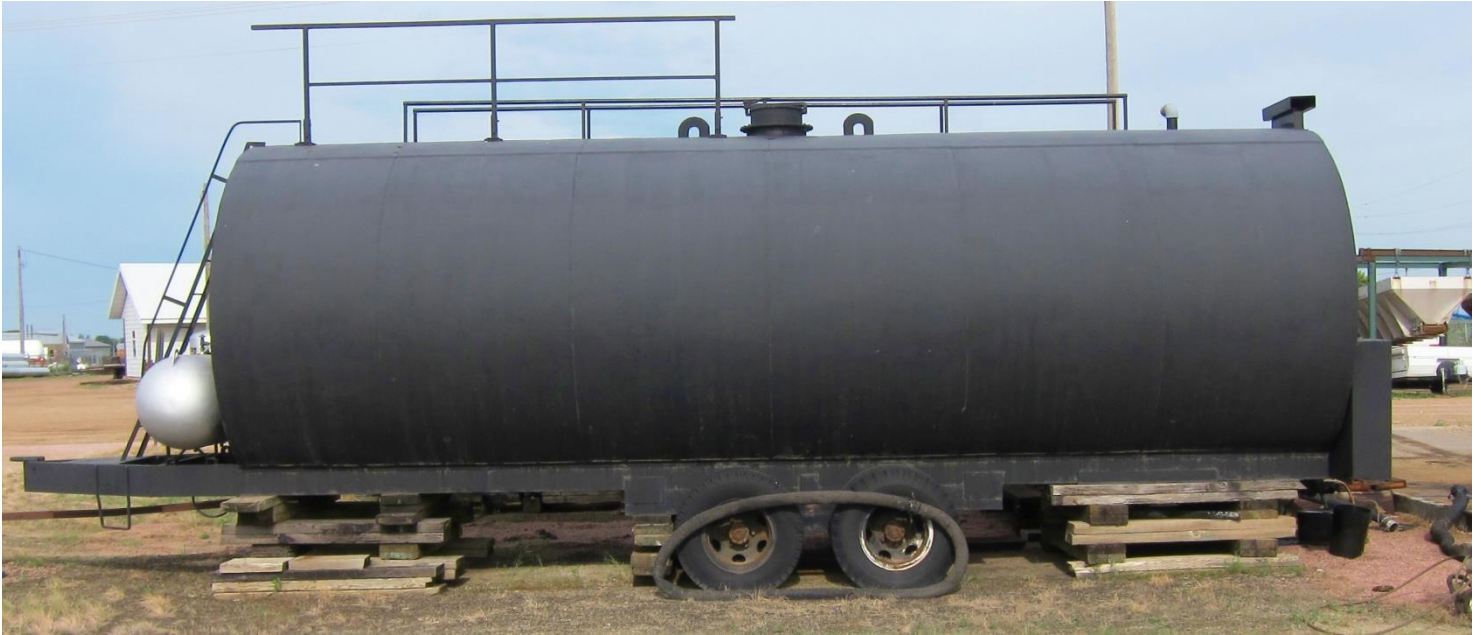
Storage tank before the application of **NCI** on June 25, 2015.

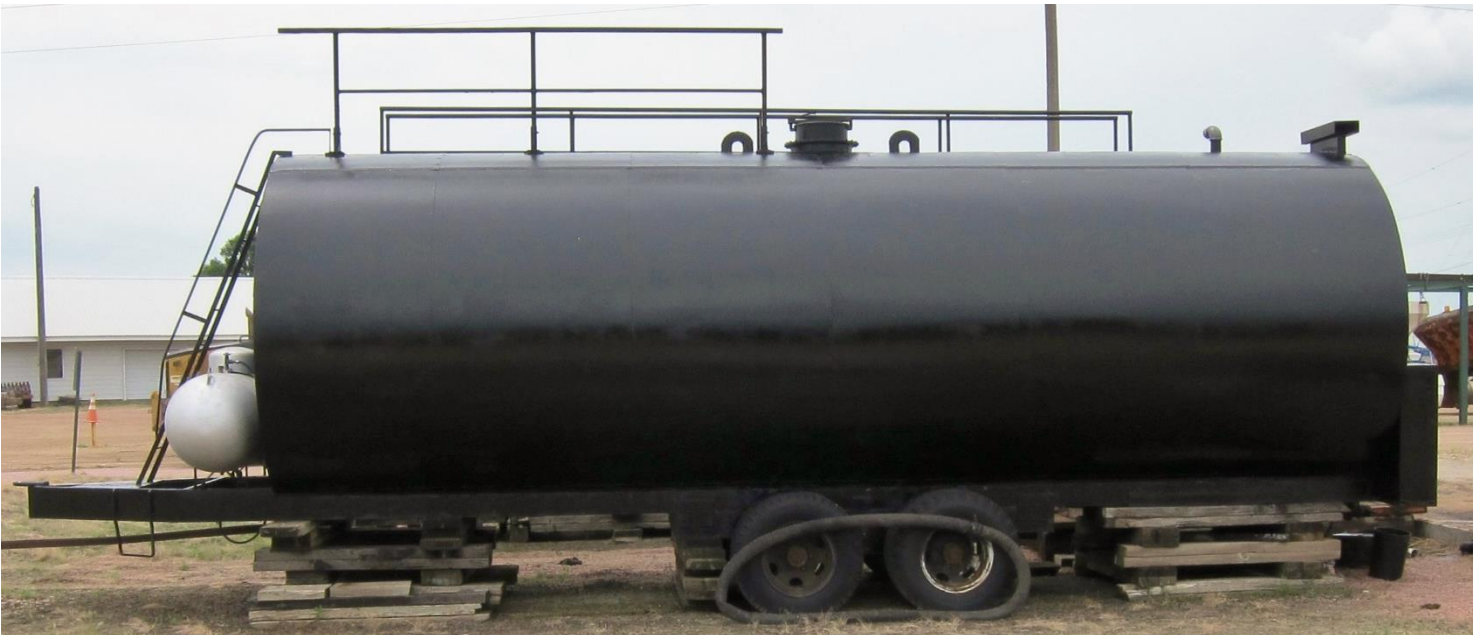
Storage tank after the application of **NCI** on June 25, 2015.

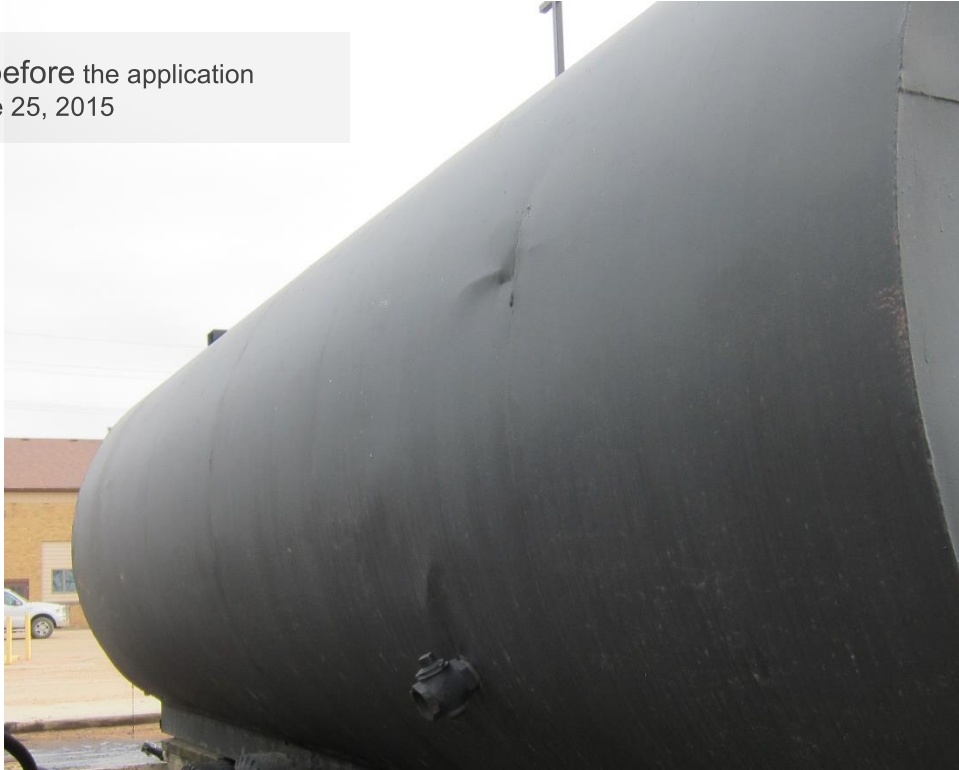
Storage tank before the application of **NCI** on June 25, 2015

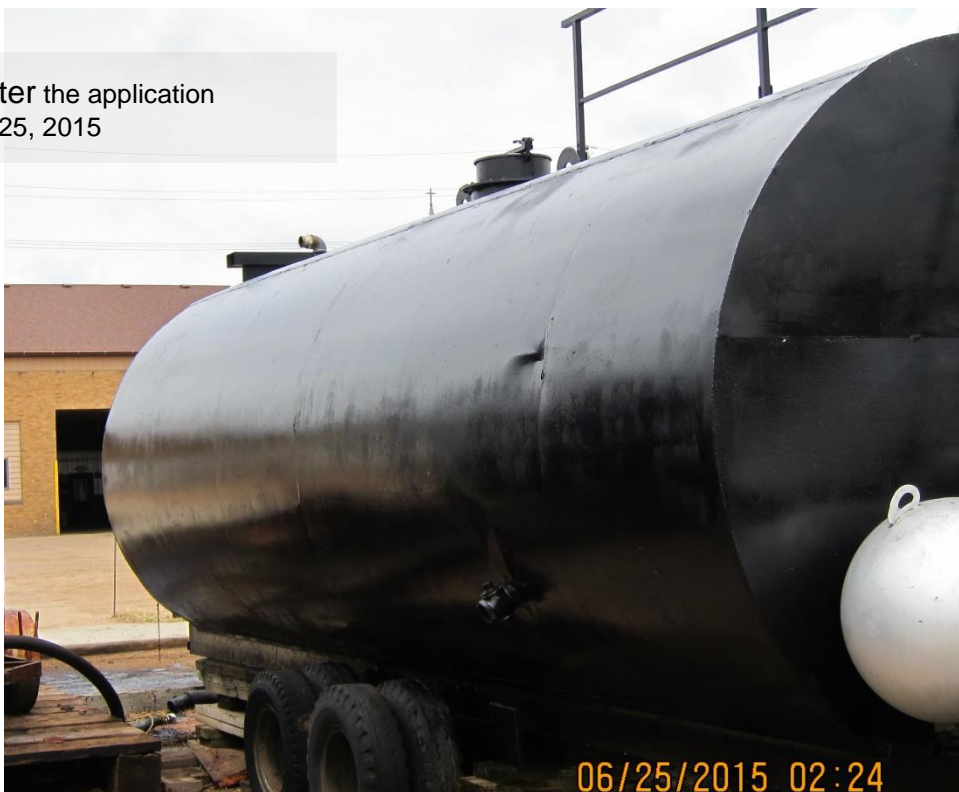
Storage tank after the application of **NCI** on June 25, 2015

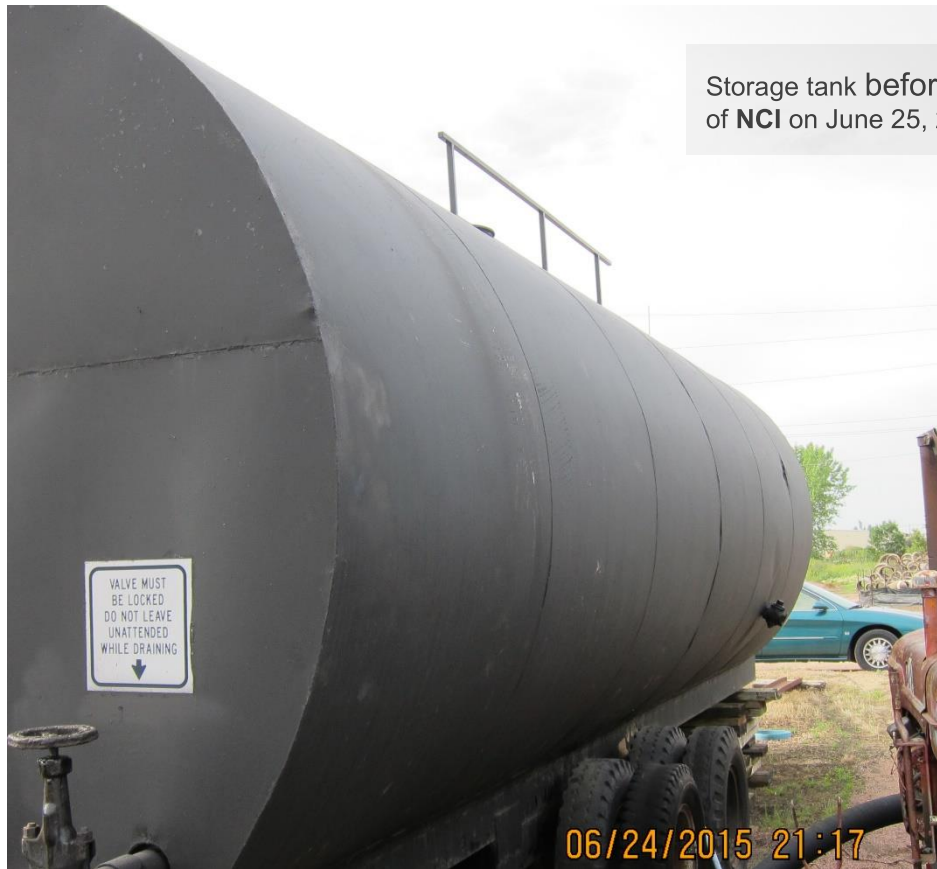
Storage tank before the application of NCI on June 25, 2015

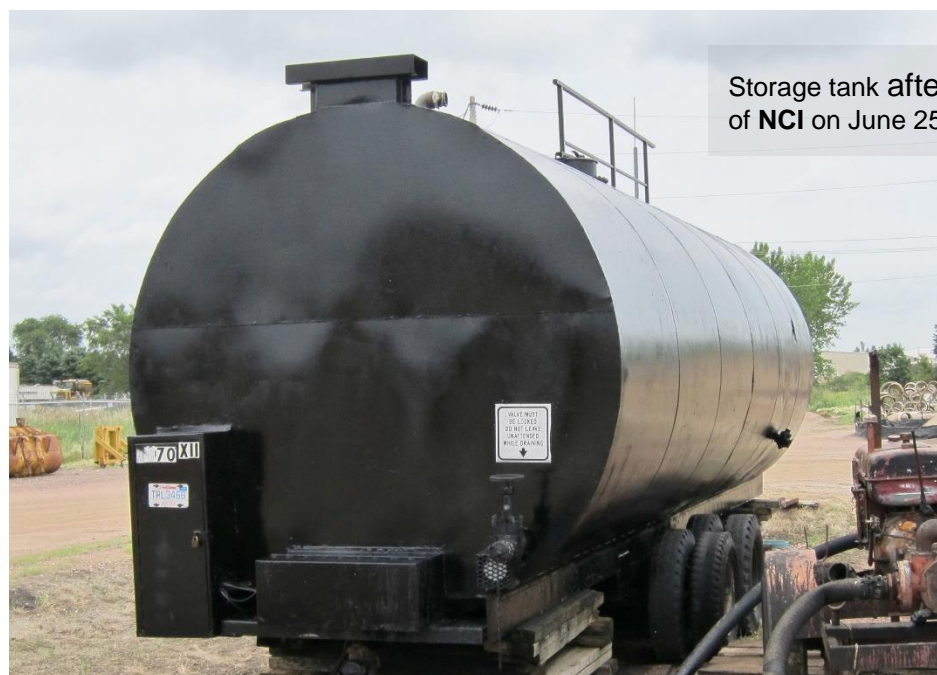
Storage tank after the application of NCI on June 25, 2015

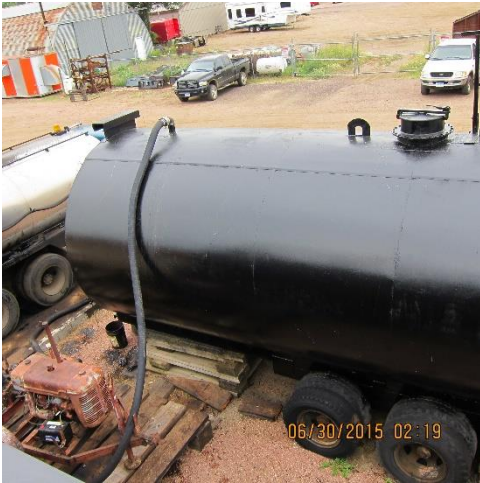
Tank #1 End – NCI

The photos of end, middle and front sections of the **NCI** coated storage tank are on the top row and the corresponding section of the storage tank that did not receive the coating is directly beneath them on the bottom row. The difference is remarkable.
